Preliminary Geotechnical Report

29 Hamilton Street
East Gore, Southland

Housing New Zealand Limited

GeoSolve Ref: 220222

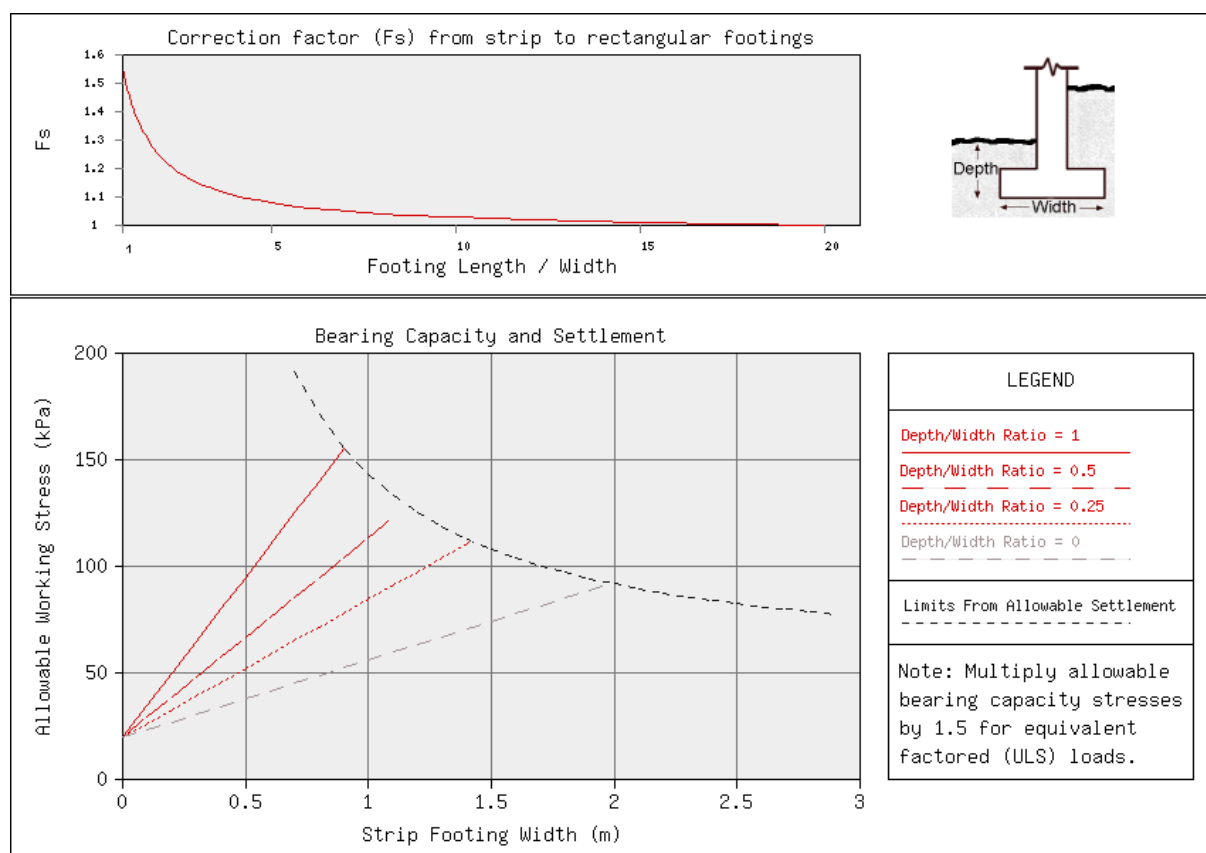
Figure 5.1 – Provisional recommended bearing for shallow footings on stiff alluvial silt

Figure 5.1 summarises the recommended provisional working stresses for shallow footings which bear upon stiff alluvial silt. It should be noted the foundation working stresses presented in Figure 5.1 are governed by bearing capacity in the case of narrow footings and settlement in the case of wide footings.

From Figure 5.1 it can be seen an allowable working stress of approximately 95 kPa is recommended for a 500 mm wide by 500 mm deep strip footing founded within stiff alluvial silt. This corresponds to a factored (ULS) bearing capacity of approximately 142 kPa and an ultimate geotechnical bearing capacity of 285 kPa.

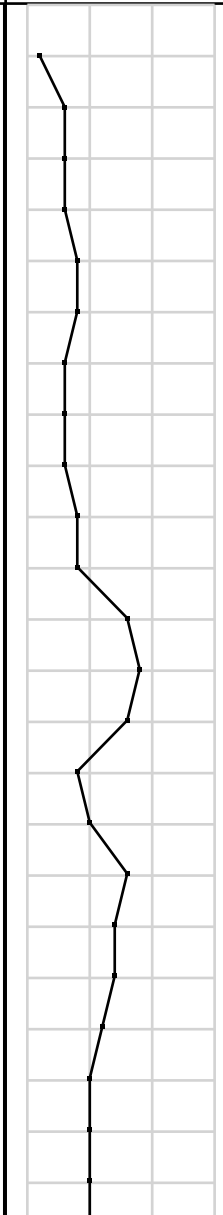
0m 0.1 0.2 0.3m	NO SEEPAGE

ALLUVIAL SILT	Sandy SILT; brown. Firm; moist; non-plastic; sand is fine.
